D. I2.4.1. TERMS OF REFERENCE FOR THE SITE WORKS ON POMPEY SITE (FR)

P. Kessouri¹

¹BRGM

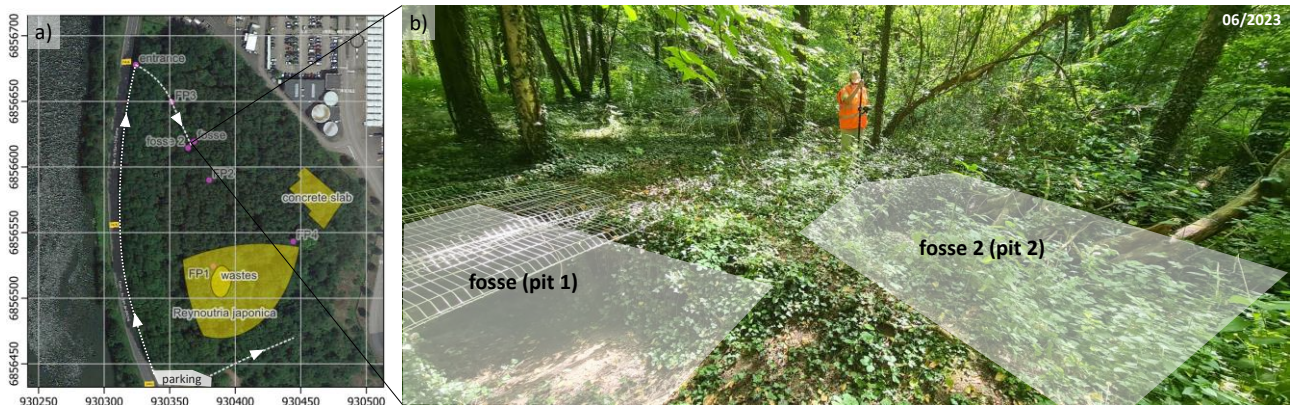
Two pits (see Figure 2) have been dug in 2010 and are still accessible, especially pit 1 that is protected from vegetation falling by a white grid covering the deepest (≤ 2 m) part of the pit. Pieces of dead trees and growing vegetation can be seen in pit 2 that has been less used over the years. Attention needs to be taken to avoid falling within the pit 2. The easiest access to the pits is through the north entrance (see Figure 1 and

Figure 2 : a) Map of the Pompey site with annotations; b) Picture of the 2 pits dug in 2010. The samples were taken in pit 1, which is still accessible and covered with a white grid to avoid vegetation (and human) falls. Pit 2 is partially covered by fallen trees and vegetation

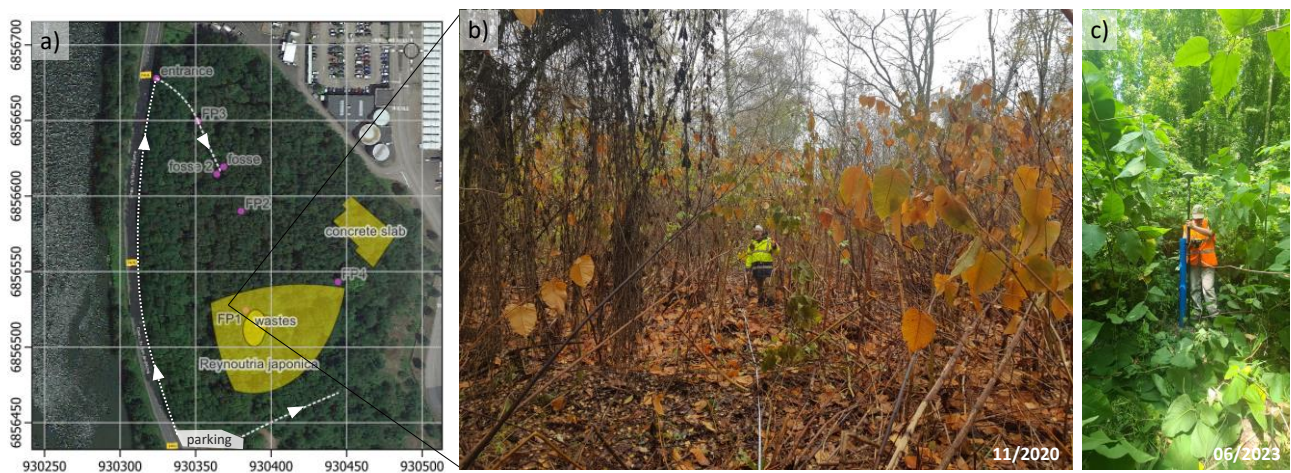
Reynoutria japonica (see Figure 4) were observed mostly on the south part of the site (see Figure 1 and Figure 4). This specie, also known as Japanese knotweed or Asian knotweed is classified as a pest and invasive species in several countries in Europe, including France (<http://especies-exotiques-envahissantes.fr/espece/reynoutria-x-bohemica/#1460369355223-03a3f531-b8ba>). Care needs to be taken when exploring this area to avoid contamination of other parts of the site and outside the pilot site.

Figure 4 : a) Map of the Pompey site with annotations; b) and c) Picture of the invasive specie "Reynoutria japonica" located mainly in the South of the site (see a) and Figure 1), at different time period (November 2020 and June 2023 respectively).

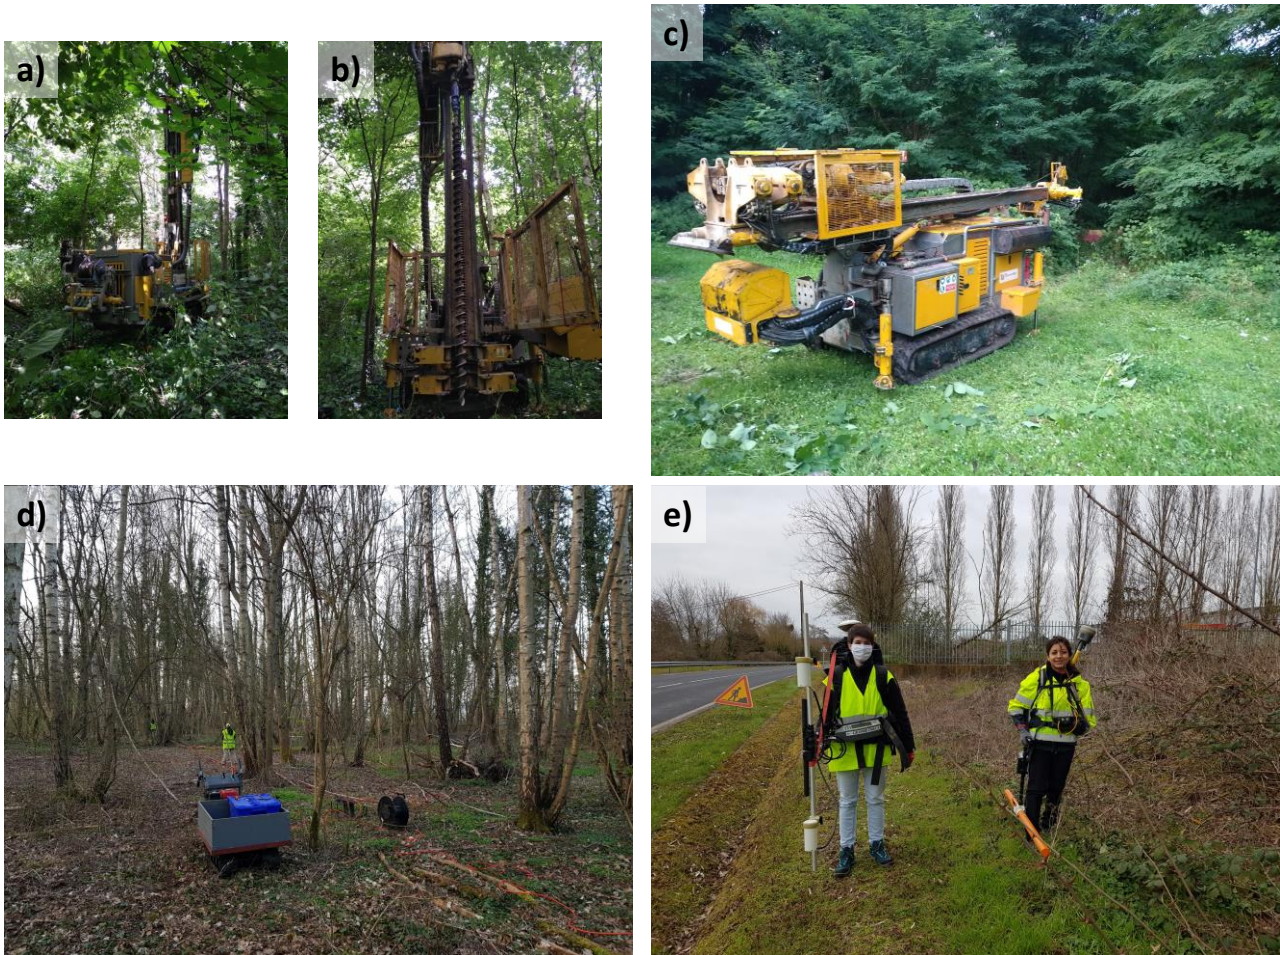
As an example, a light core drill on crawler was used to drill the 4 boreholes on site (see Figure 6 a, b and c). A Light crawler wheelbarrow was used to carry the heavy geophysical equipment on site (see Figure 6 d). These tools allow sufficient lift on the Pompey soils that have poor bearing capacity (see deliverable DI2.3.1 and ANTEA, 2001a, 2001b). Indeed, the soils are delicate to excavate and sensitive to water, which require the use of suitable equipment.

Figure 6 : a), b) and c) light core drill used on site to dig the 4 boreholes FP1 to FP4. d) Light crawler wheelbarrow used to carry geophysical material (batteries and cables) on site; e) Geophysical tool used on site carried out manually at the North entrance of the site (see Figure 1).

Because of the vegetation, and the nature of the soils that have poor bearing capacity, the circulation on the site is only possible by foot, or using a light transportation mode to carry instruments. For example, a crawler wheelbarrow was used to carry heavy geophysical equipment.
